Division of
Oil, Gas & Mining

SUBJECT: Site Inspection, American Gilsonite, Bonanza Operations,
M/047/010, Uintah County, Utah

Date of Inspection: July 7, 2004
Time of Inspection: About 12:30 to 6:45 p.m.
Conditions: Partly to mostly cloudy with a few showers, 80's
Participants: Clay Taylor, American Gilsonite; Paul Baker, DOGM

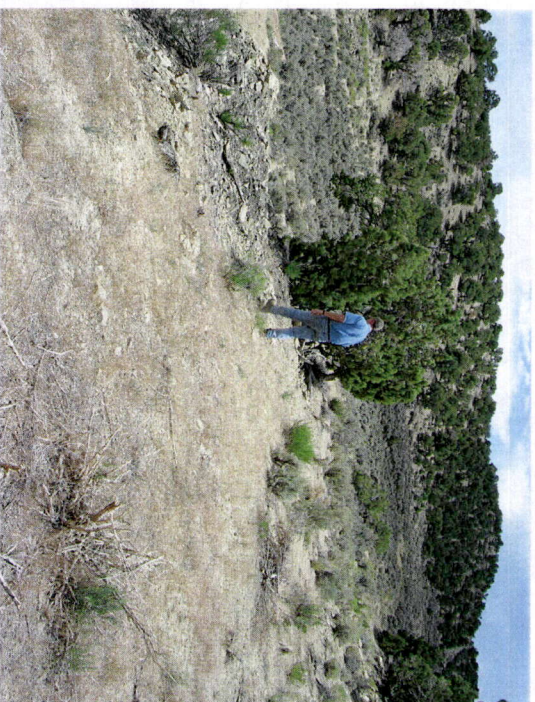
Photo 4. R-4.

I did not see any problems with the polyurethane foam used at sites R-4, H-2, and H-10. The Division originally approved use of polyurethane foam as an experimental practice and said it anticipated a minimum period of five years
